## CARRIAGE HOUSE, MINNEAPOLIS, MN

### MS-D1 SHOTCRETE

<b>PROJECT:</b>	Carriage House Retaining Wall, Minneapolis, MN
<b>SPECIFIER:</b>	Partners & Sirny Architects Minneapolis, MN
<b>CONTRACTOR:</b>	Brent Anderson Associates Fridley, MN
<b>PRODUCT:</b>	MS-D1 Shotcrete
<b>QUANTITY:</b>	20 m <sup>3</sup> (700 ft <sup>3</sup> )
<b>COMPLETION:</b>	Spring 2005

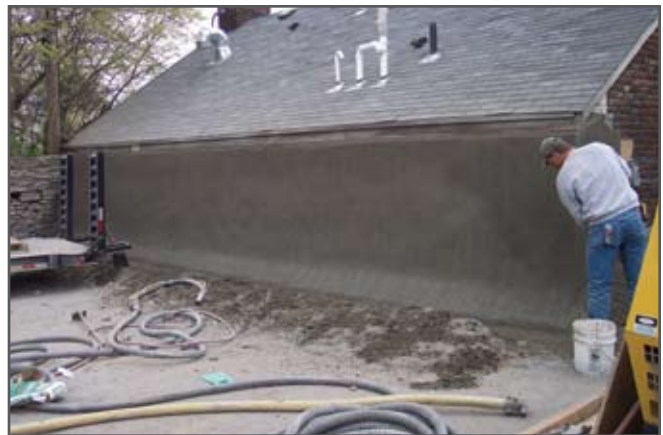
This project is an excellent example of the flexibility and capability of shotcrete. Many projects regardless of scale, originally thought to be typical form and pump repairs lend themselves to either the wet or dry-mix shotcrete process. Projects such as this can be completed without the costly additions of formwork and as the photograph illustrates, the finished product is as aesthetically pleasing as any cast-in-place type of repair.

Brent Anderson and Associates worked closely with the project architects to address the concerns about the stone wall and proposed to use shotcrete as a method to repair the structure. The deteriorated sections of wall were chipped and the entire surface was high pressure water-blasted and cleaned. Galvanized, welded-wire mesh supported by stainless steel pins was anchored to the stone to provide mechanical bond to the wall. Brent Anderson Associates chose to shoot King's MS-D1 Shotcrete because its air entrained properties provided long-term durability in an environment that was exposed to continuous freeze-thaw cycles. The owner's concerns about the aesthetic qualities of shotcrete were alleviated after BAA technicians shot the wall, cut it to a uniform plane and finished it with a broom texture.
